# SUZUKI

# Service Bulletin

Bulletin No. GT-34

Subject: GT500 SHIFTING CAM GUIDE BOLT LOCATION  
REFERENCE: Service Bulletin #T-5

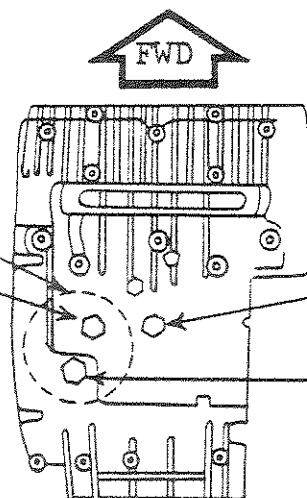
Bottom View of Lower Crankcase Hal

We have received occasional reports of GT500 transmission failure immediately after an engine or transmission overhaul. Upon disassembling and inspecting the transmission, it was found that the transmission oil drain plug and the shift cam guide bolt had been mistakenly interchanged during the overhaul.

The shift cam guide bolt restricts the shift cam drum from sliding from side to side inside the crankcase assembly. When these two bolts are interchanged, the oil drain plug does not extend into the locating groove of the shift cam drum, allowing the drum to slide from side to side. When this happens the shifting forks slide with the shift cam, allowing two sets of gears to become engaged at the same time. This results in severe damage to the gears, and requires their replacement.

NOTE: Remove both bolts to drain oil. After draining oil make sure of correct placement of both bolts.

Therefore, whenever a GT500 is overhauled, or the transmission oil changed by your service department the final inspection after re-assembly should be the proper placement of the shift cam guide bolt and oil drain plug.

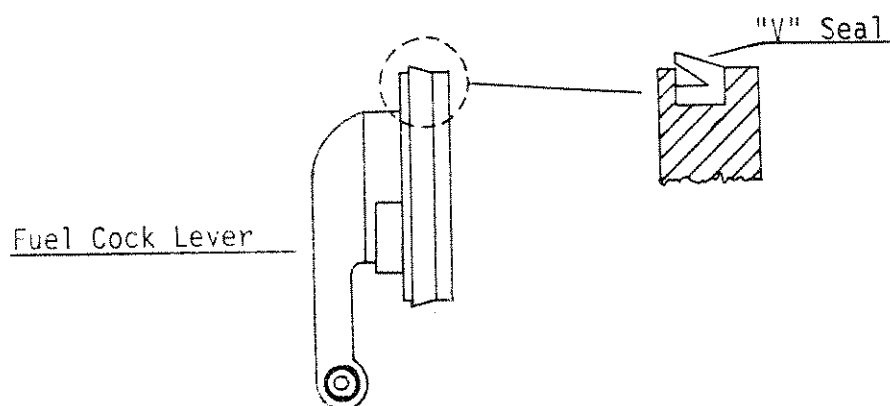
To prevent fuel cock seepage, a "V" seal has been installed around the fuel cock lever, to seal the lever to the fuel cock body, as illustrated below.

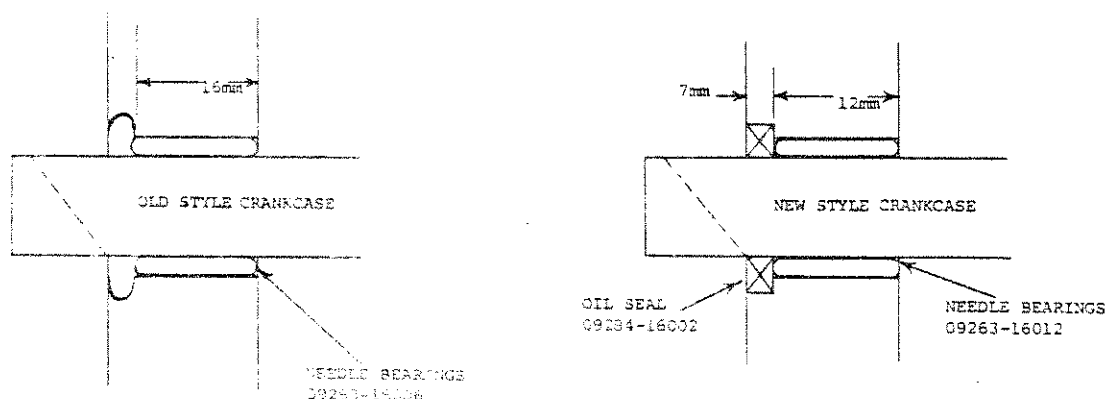
To strengthen the GT380/550/750's gear shift indicator switch's body, its material has been changed from phenolic to metal, and its shape changed.

At the same time, the crankcase has been changed to accept an oil seal for the gear shifting camshaft. This will prevent metal particles in the transmission oil from damaging the switches' "O" rings, thus allowing oil to seep past. The crankcase modifications are listed below:

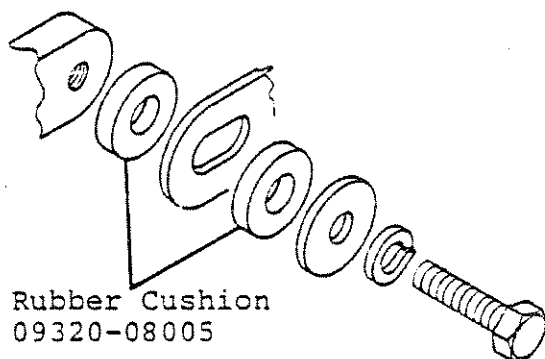
TYPE 1

The Type 1 method is a "semi-floating" mount. A rubber cushion is used with the original type fender to provide a small amount of flexibility. With this type of mount, the mounting bolt must be secured with thread lock cement.

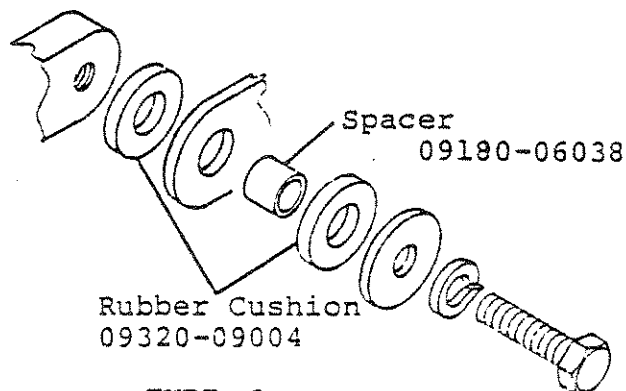
TYPE 2

The Type 2 method is a "floating" mount. The front fender brace has been changed and it is mounted by a rubber cushion and a spacer. This mounting method will provide a secure yet flexible mount for the front fender.

There are presently three ways to mount the A and B model GT500 front fender brace to the front fork outer tube. To distinguish the different mounting methods from each other, they are labeled the Original method, the Type 1 method, and the Type 2 method. If any original or Type 1 front fender has to be replaced, it must be updated to the Type 2 fender.
