# SUZUKI

# Service Bulletin

Bulletin No. GT-34

Subject: GT500 SHIFTING CAM GUIDE BOLT LOCATION  
REFERENCE: Service Bulletin #T-5

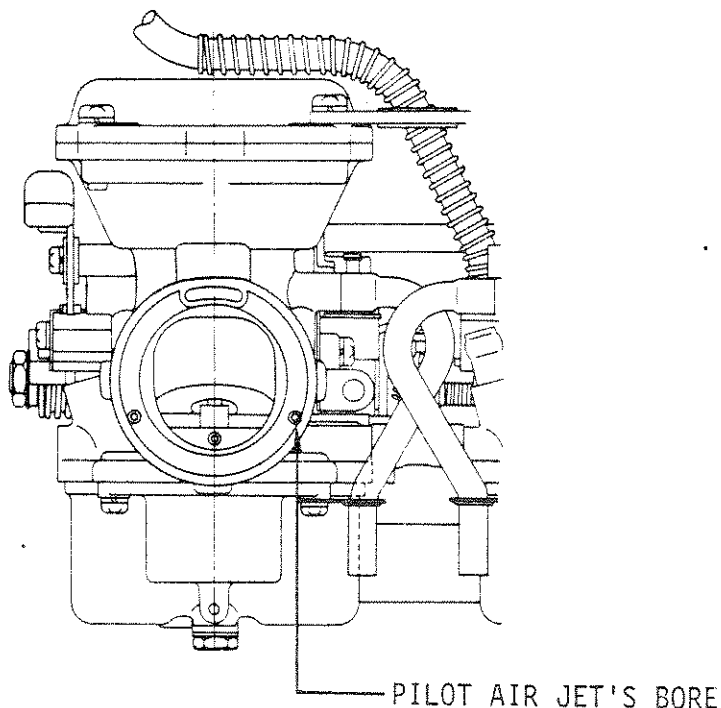
The #80 reduction jet would normally be used in the 1975M, 1976A, and 1977B models. The #90 reduction jet would normally be used in the 1974L model. These are the suggested applications and depending on geographical area and engine conditions, it may be necessary to select the alternate jet.

The installation of these reduction air jets will richen the idle mixture considerably. On certain machines, it may be necessary to adjust the jet needle position one step leaner to eliminate an "off idle" hesitation. Before the needle position is altered, the pilot air screw's adjustment and carburetor synchronization should be carefully adjusted.

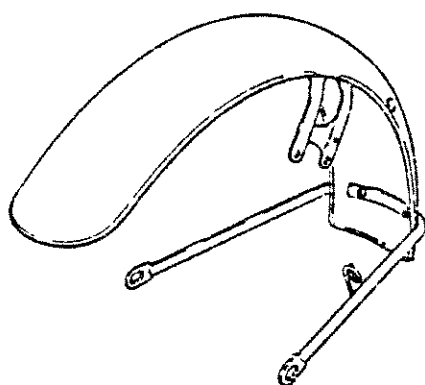
There are presently three ways to mount the A and B model GT500 front fender brace to the front fork outer tube. To distinguish the different mounting methods from each other, they are labeled the Original method, the Type 1 method, and the Type 2 method. If any original or Type 1 front fender has to be replaced, it must be updated to the Type 2 fender.
